PART# 8319MR

**2019+ GM 1500 2WD/4WD
MODELS WITH ADAPTIVE RIDE SUSPENSION**

**FRONT SENSOR PROVISIONS
FOR 2", 2.5" OR 3" STRUT SPACERS**

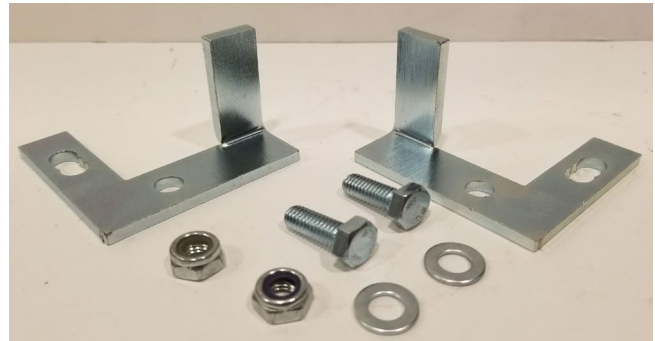
(1) 8319MR-D DRIVE SIDE SENSOR BRACKET

(1) 8319MR-P PASS SIDE SENSOR BRACKET

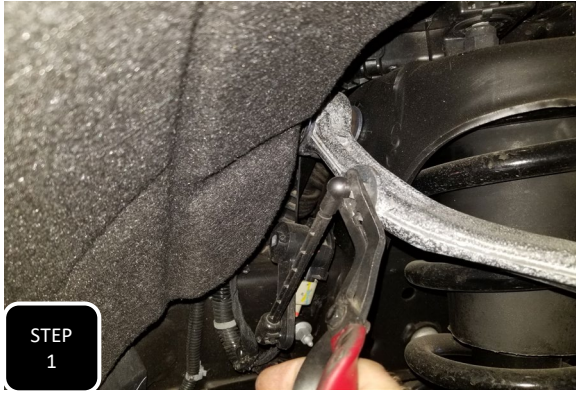
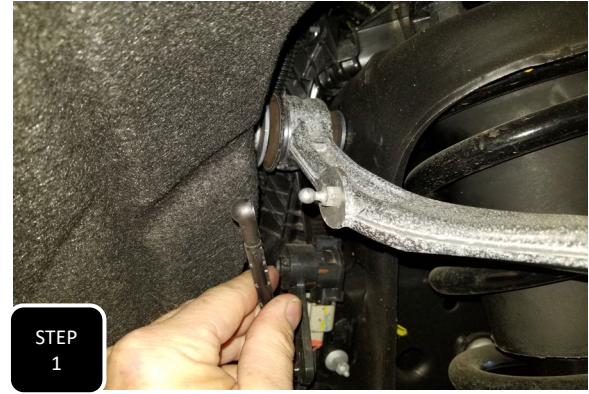
Step 1 Using a suitable pair of pliers or a flat head screw driver, pry the rod end off of the mounting ball at the front of the upper control arm.

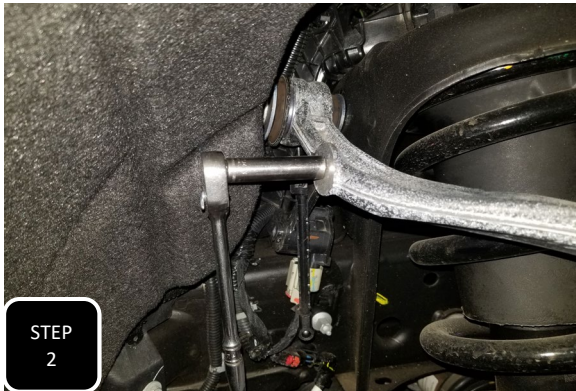
Step 2 Using a 10mm deep socket, remove the mounting ball from the upper control arm.

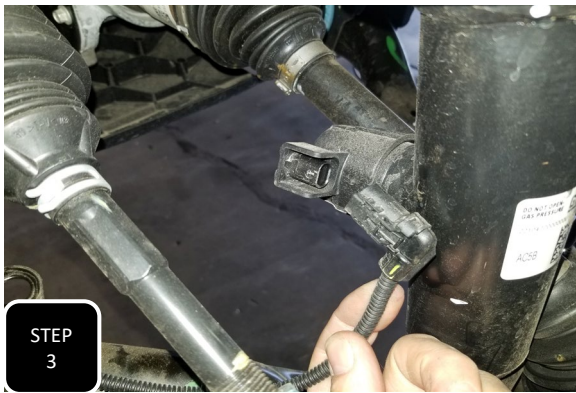
Step 3 Unplug the wire connection at the body of the front strut and then proceed with installing the strut spacers and then move to step 4.

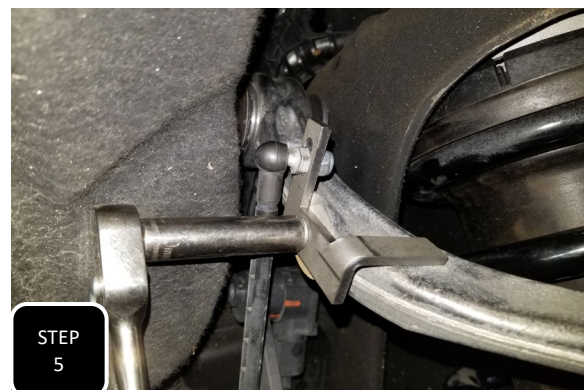
Step 5 Pop the sensor rod onto the mounting ball using a set of channel lock pliers and squeeze. Next, attach the bracket to the upper control arm using the supplied M6-1.0 x 16 bolt and flat washer. The bent tab needs to sit flat on top of the control arm.
